**DEPARTMENT OF TRANSPORTATION**

Contract #: 04-0120F4Cty: SF/ALA Rte: 80 PM: 13.2/13.9File #: 69.28**WELDING INSPECTION REPORT****Resident Engineer:** Pursell, Gary**Address:** 333 Burma Road**City:** Oakland, CA 94607**Report No:** WIR-002268**Date Inspected:** 06-May-2008**Project Name:** SAS Superstructure**OSM Arrival Time:** 1500**Prime Contractor:** American Bridge/Fluor Enterprises, a JV**OSM Departure Time:** 2230**Contractor:** Zhenhua Port Machinery Company, Ltd (ZPMC), Changxing Island **Location:** Shanghai China**CWI Name:** See observations below**CWI Present:** Yes No**Inspected CWI report:** Yes No N/A**Rod Oven in Use:** Yes No N/A**Electrode to specification:** Yes No N/A**Weld Procedures Followed:** Yes No N/A**Qualified Welders:** Yes No N/A**Verified Joint Fit-up:** Yes No N/A**Approved Drawings:** Yes No N/A**Approved WPS:** Yes No N/A**Delayed / Cancelled:** Yes No N/A**Bridge No:** 34-0006**Component:** Tower skin plates**Summary of Items Observed:**

# WELDING INSPECTION REPORT

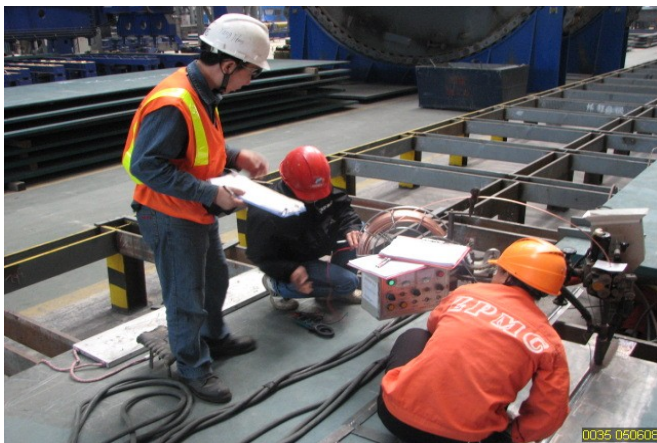
Item	Description	WBS	Dwg No.	Status
1	Picture 1 CWI Au Jing Xangm monitoring & recording welding current parameters on tower skin plates			
2	Picture 2 Pre-heating of weld joint in tower shop (Typical)			
3	Picture 3 Typical minor VT indications (slag etc) marked by CWI prior to subsequent weld passes be applied. (later ground and removed)

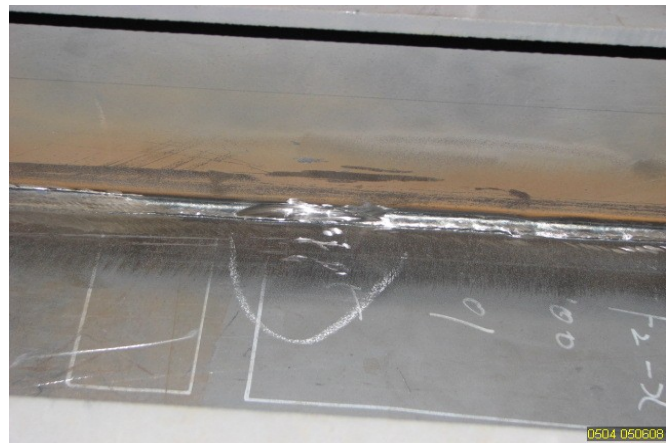
4 Picture 4

Typical excavations & repair of VT indications on GMAW fillet welds to the WT stiffeners on SP094-001

The Caltrans QA Inspector performed in-process visual inspection on the Shielded Metal Arc Welding (SMAW) process tack welding & fit-up on WT Stiffeners to the OBG bottom plates BP114-001 & FCAW minor repairs to fillet welds on SP094-001 in Bay#3. QA Inspector randomly observed the ZPMC CWI Mr. Wu Ming Kat monitoring welding voltage, pre-heat & interpass temperatures & cleaning, weld pass width, profile/size and travel speed per approved WPS-B-P- 2112 & WPS-345-FCAW-2G (2F).
